## 815 Tennessee Street P.O. Box 188 Bolivar, Tennessee 38008

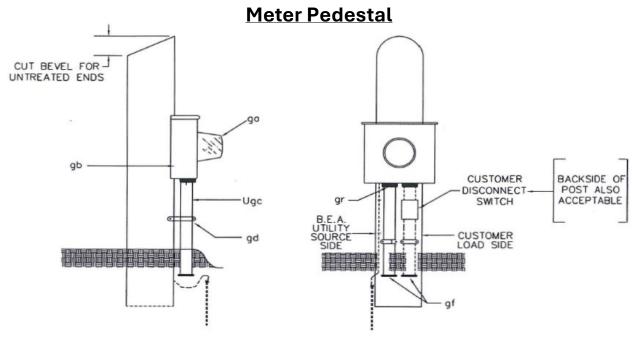
- 1. BEA engineering staff must spot meter base location prior to meter base installation.
- 2. Customer to provide trenching and backfill. Trench must be a minimum of 3 ft deep. Warning tape to be installed in trench, 12 inches below top of grade.

- Customer to provide ALL conduit from meter base to & up BEA pole, including 90s.
  a. Conduit size must meet or exceed the 3" conduit size requirement.

- 4. Customer to provide weather head and straps as needed for conduit up BEA pole.
  - a. BEA to install customer provided conduit up BEA pole.
- 5. Conduit up pedestal to meter base, up BEA pole, and under any area subject to vehicle traffic or concrete shall be SCH 80 conduit. All other can be SCH 40 conduit.

- 6. SCH 80 conduit 90s to be provided and installed at meter base end and BEA pole end of conduit run. No more than (2) 90s in conduit run. No 45s to be used in conduit run.

- 7. Customer installed conduit shall be left weatherproofed with a pulling string or rope installed in conduit and extending through weatherproofing.
- 8. BEA to provide and install all electric cable from BEA transformer to customer meter base. BEA to make connections at transformer and top side of meter.

- a. Cost for installed electric cable is \$4.00 per foot for single phase. This footage includes from the transformer to the meter base.
- 9. A treated 6" x 6" square post in concrete or a meter mounted on unistrut and unistrut installed on post for conduit attachment is acceptable.

- 10. Left side of meter base reserved for BEA use.
- 11. Any single-phase service entrance greater than 400 amp, the customer is responsible for conduit AND cable. BEA will CT the service on the transformer pole, a CT fee of \$1000 will apply.

- 12. Trench and conduit to be inspected by State of Tennessee Electrical Inspector prior to trench being backfilled or site pipes must be installed if backfilling before inspection. The meter base and conduit/ditch must pass a State of Tennessee electrical inspection prior to BEA service connection.
